# Manhole Inspection Summary

Manhole # S41GG\_020MH

Insp Date: **6/22/09 10:03 AM**

**Location** Address: **1512 PRESTON ST**

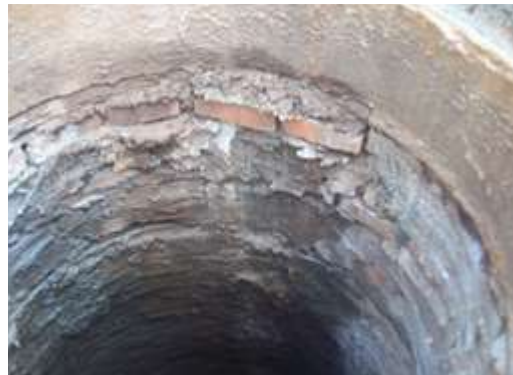
Defect 2

Condition: ☐ Sound ☐ Cracked ☐ Root Intrusion ☐ Loose Brick ☒ **Deteriorated**

DETERIATED CHIMNEY

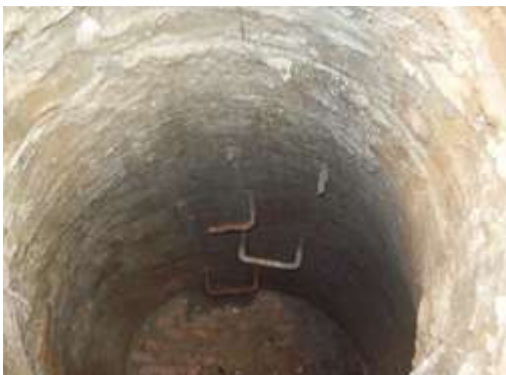
Defect 1

Count: **2** Missing: **2** ☒ **Corroded**

CORRODED STEPS

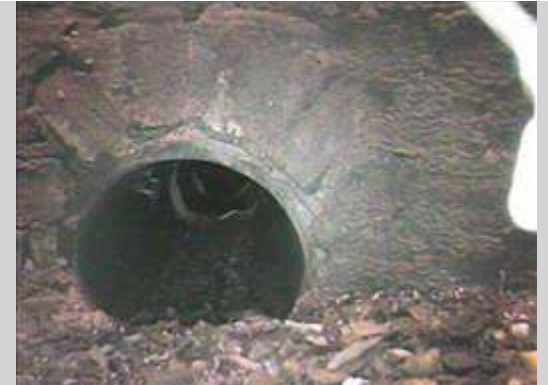
12 O'Clock Outflow

8 in. Circular Gravity Sewer  
Pipe Out @ 12 O'Clock

Pipe Material: **Clay** ☐ Pipe Lined

Infiltration: **None** Pipe Seal Cond: **Sound**
